**COATINGS FOR PROTECTION OF EQUIPMENT FOR
BIOCHEMICAL PROCESSING OF GEOTHERMAL
RESIDUES: PROGRESS REPORT FY'97**

November 1997

**M.L. Allan
Brookhaven National Laboratory**

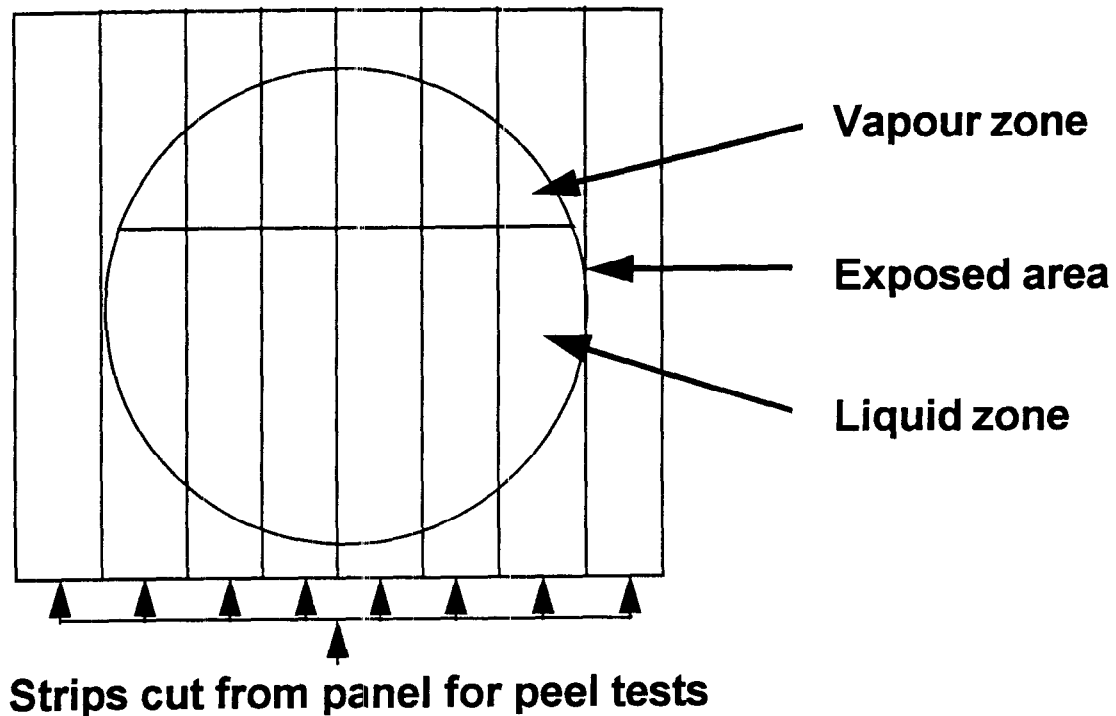
Figure 1. Schematic diagram of peel test specimens cut from Atlas cell panels.

At the completion of the tests the coated panels were visually examined for signs of deterioration such as blistering, discolouration and loss of gloss. The residual adhesion was determined for EMAA coatings by measuring the peel strength (ASTM D 3167). The plates were cut into strips 25 mm wide and the orientation was vertical so that the strip traversed the vapour and immersion-exposed zones. The strips cut from the outer edges of the plates were beyond the exposure zone. A schematic diagram of the strips cut from the panels is presented in Figure 1. The coatings were peeled back approximately 40 mm using a razor blade to enable the coating to be gripped. An Instron tensile testing machine was used. The crosshead speed was 152 mm/min. It was not possible to measure the peel strength of the ETFE coatings because the material was too brittle to bend 90°.

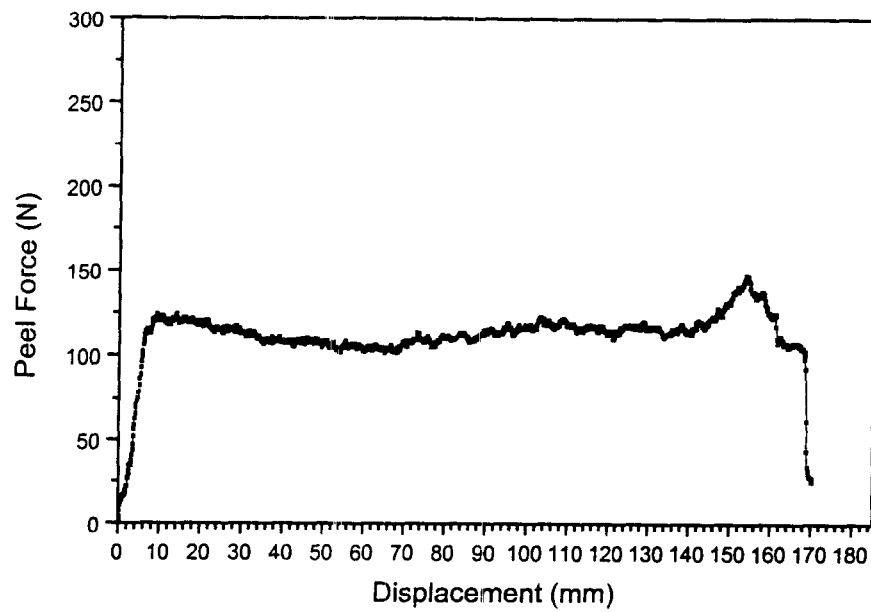
Figure 4. Peel force-displacement curve for EMAA outside brine-exposed zone.

Figure 4 depicts the peel load versus displacement curve for a strip cut from the edge of one of the panels. The coating in this location was not exposed to brine. The peel force was relatively constant and the failure mode was adhesive. The average peel strength was 4.33 N/mm. The steel and polymer surfaces after peeling are shown in Figure 5. Figure 6 shows the results for a strip cut through an exposed area. The peel force was low in the initial region and this corresponded to the presence of corrosion products at the interface. The increase in peel force at higher displacement occurred outside the exposed area (at the gasket and beyond). Peel strength varied from 1.97 to 6.97 N/mm. Figure 7 shows the peeled steel and polymer surfaces. Figure 8 is another example of low peel forces in the corroded exposed area and increased values before and after this. Plastic deformation of the coatings occurred during peeling and this was concentrated in the areas outside the test cell where greater force was required to remove the coating. Figure 9 shows the peeled steel and polymer surfaces corresponding to the force-displacement curve in Figure 8. All of the above tests were taken from the EMAA panel with corrosion in both the liquid and vapour zones.

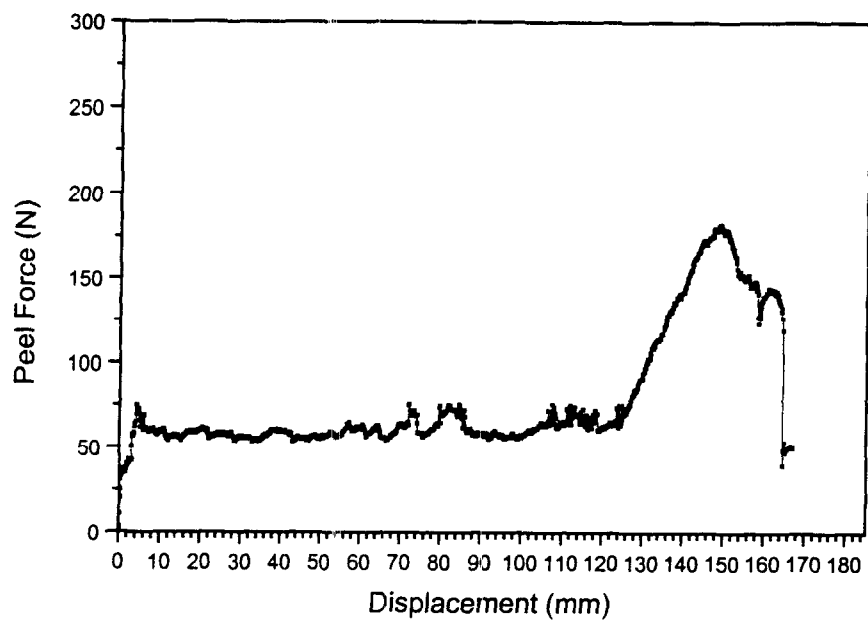
Figure 6. Peel force-displacement curve for EMAA exposed to brine.

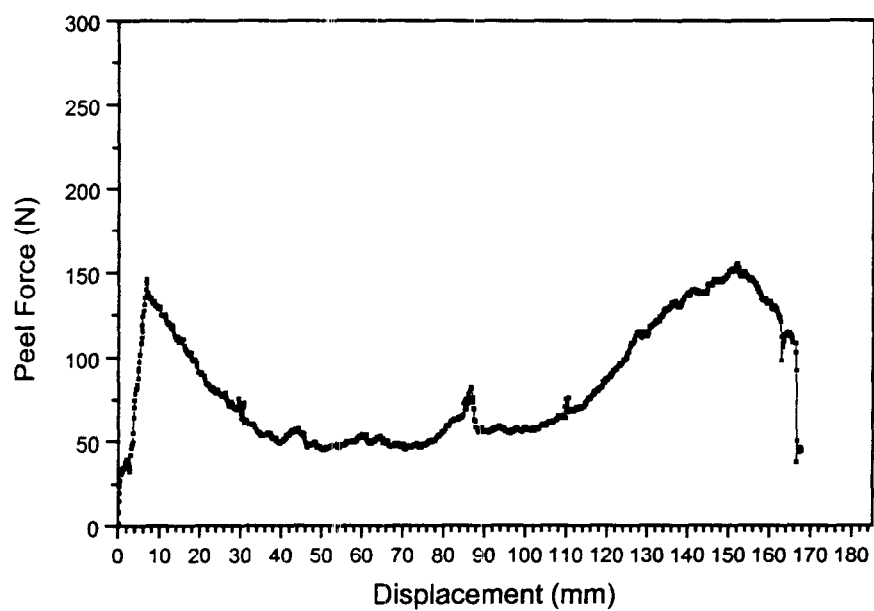
Figure 8. Peel force-displacement curve for EMAA exposed to brine.

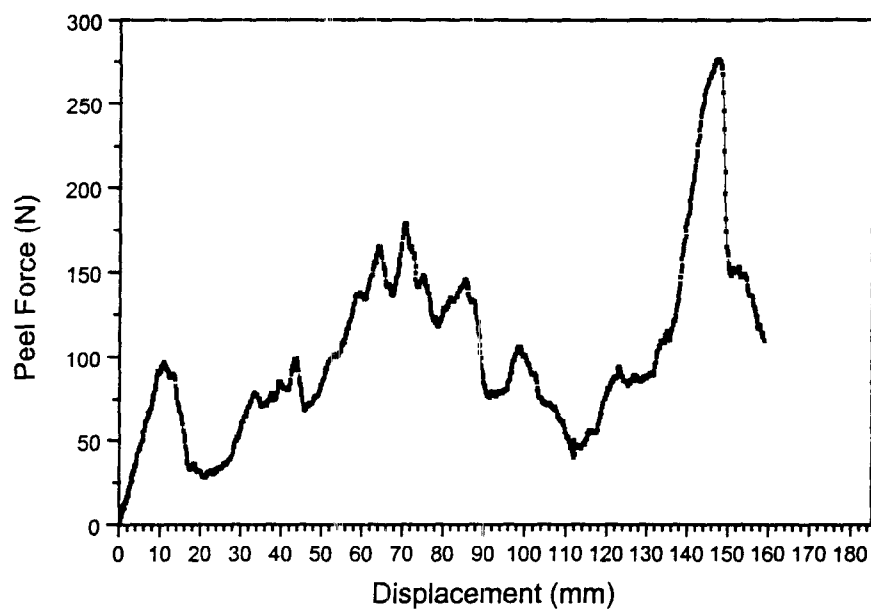
Figure 10. Peel force-displacement curve for EMAA exposed to brine.

The following peel test descriptions are for the panel exposed to brine with corrosion predominantly in the vapour zone. Figures 10 and 11 present typical peel test results for specimens cut through the exposed zone. Both of these figures show great variation in peel force along the length of the specimen. Low peel forces corresponded with the presence of oxides at the interface and adhesive failure. Increased forces in the exposed area correlated with cohesive or mixed adhesive/cohesive failure. Force required to peel the coating typically increased towards the end of the specimens beyond the test cell. In these specimens the peel strength varied from 0.98 to 10.87 N/mm. The surfaces of two of the specimens after peeling are shown in Figures 12 and 13. Cohesive failure of the polymer is evident, as are oxides predominantly in the vapour zone. The peel test result for a strip cut through the edge of the exposed zone is shown in Figure 14. Cohesive failure occurred beneath where the gasket contacted the polymer coating and peel strength ranged from 5.51 to 11.02 N/mm. Figure 15 shows the more constant force required to peel the coating outside the exposed zone. The average peel strength is around 5.51 N/mm.

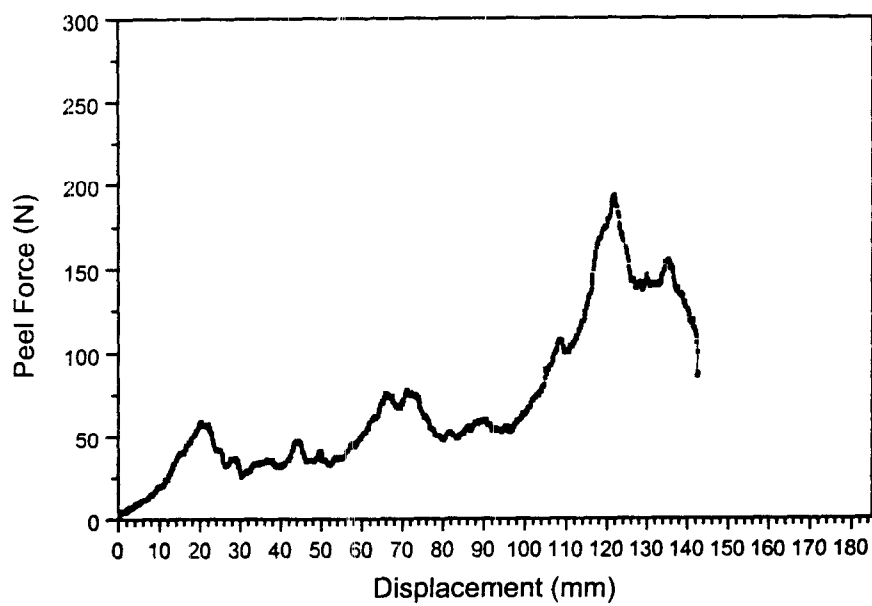
Figure 11. Peel force-displacement curve for EMAA exposed to brine.

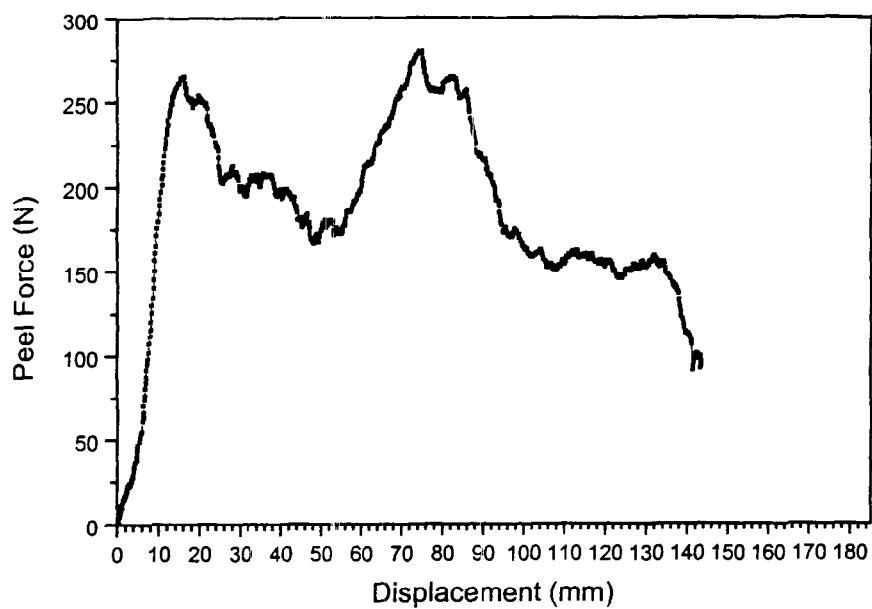
Figure 14. Peel force-displacement curve for EMAA at edge of brine-exposed zone.

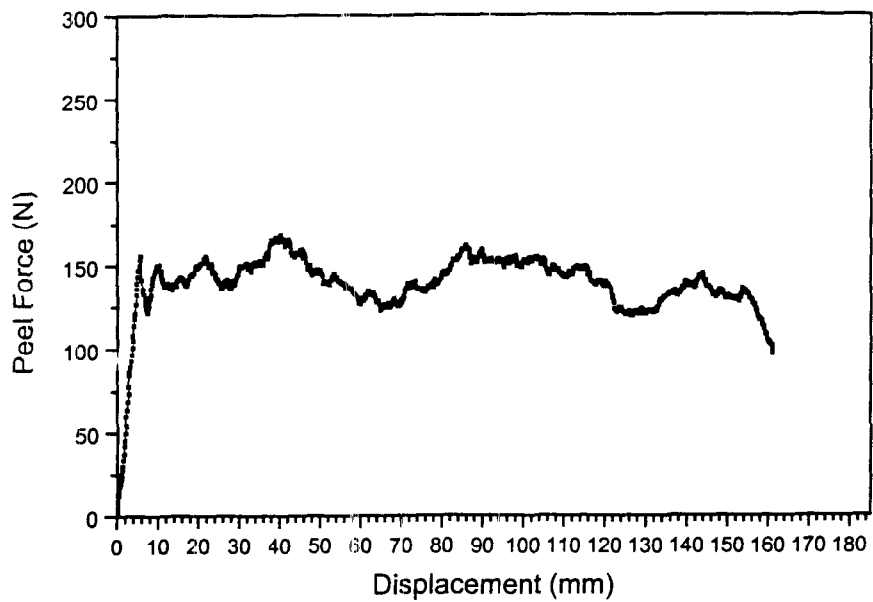
Figure 15. Peel force-displacement curve for EMAA outside brine-exposed zone.

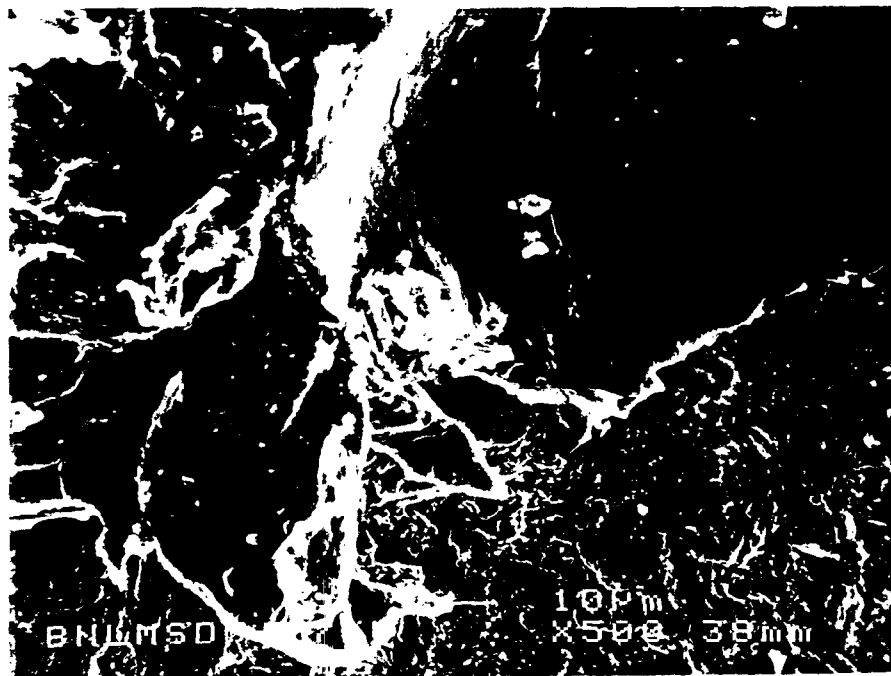
Figure 17 Higher magnification view on Fig. 16 showing failure through pore in polymer.

Fracture surfaces from the EMAA-mild steel peel tests were examined under a scanning electron microscope (SEM). An example of mixed adhesive/cohesive failure in an uncorroded area is shown in Figure 16. The dark areas are polymer adhering to the steel surface. Spherical pores, 100 - 200 μm diameter, in the polymer are evident and failure often occurred through these pores. Figure 17 is a higher magnification view of a fractured pore. Figure 18 shows the steel surface at the liquid/vapour transition zone. Spots of corrosion product are indicated. The polymer adhered to the steel in the uncorroded areas. Where corrosion occurred, failure was between the polymer and corrosion products, or within the

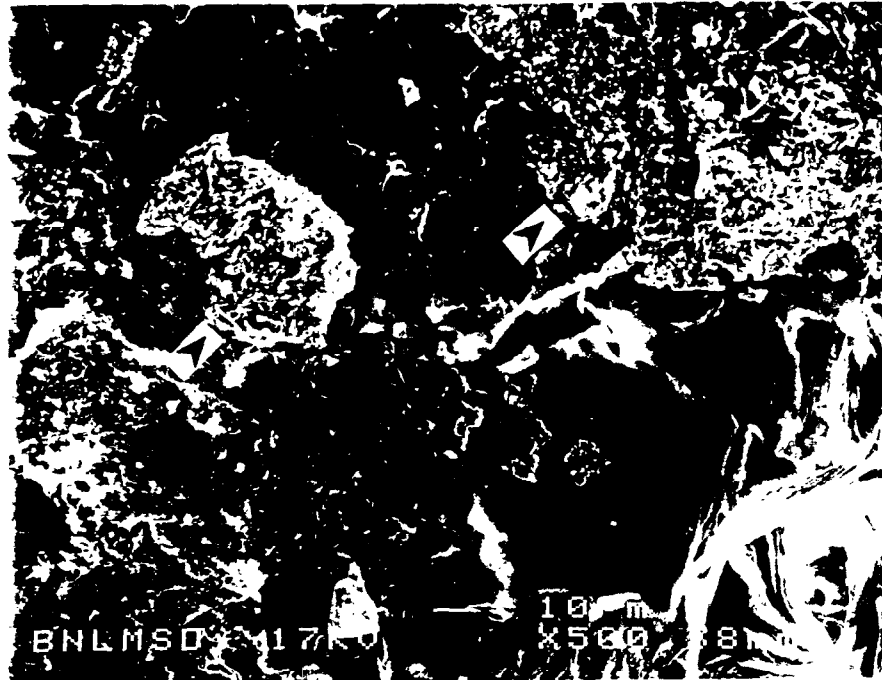
Figure 18. SEM micrograph of steel fracture surface. Dark areas are polymer, light areas are iron oxides (arrowed).

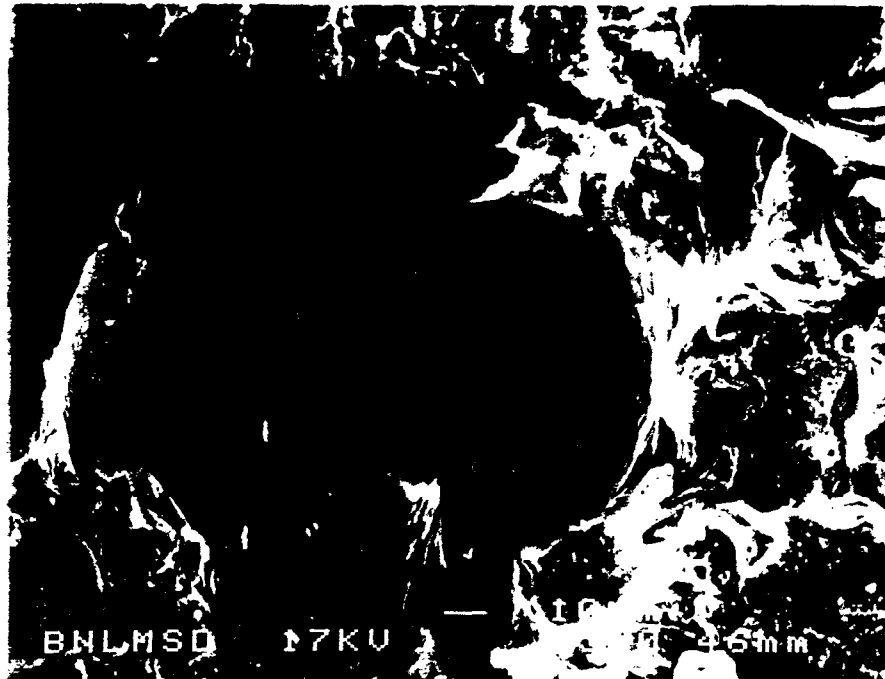
Figure 20 Polymer fracture surface at higher magnification showing ductile tearing around edge of pore

products themselves. Figures 19-21 depict the fracture surface of the polymer. Figure 19 shows pores in the polymer surface. Ductile tearing of the polymer around the edges of a pore is evident in Figure 20 (1-5B). Tearing is visible in Figure 21 (1-5A), as is coalescence of voids < 5 μm in diameter.

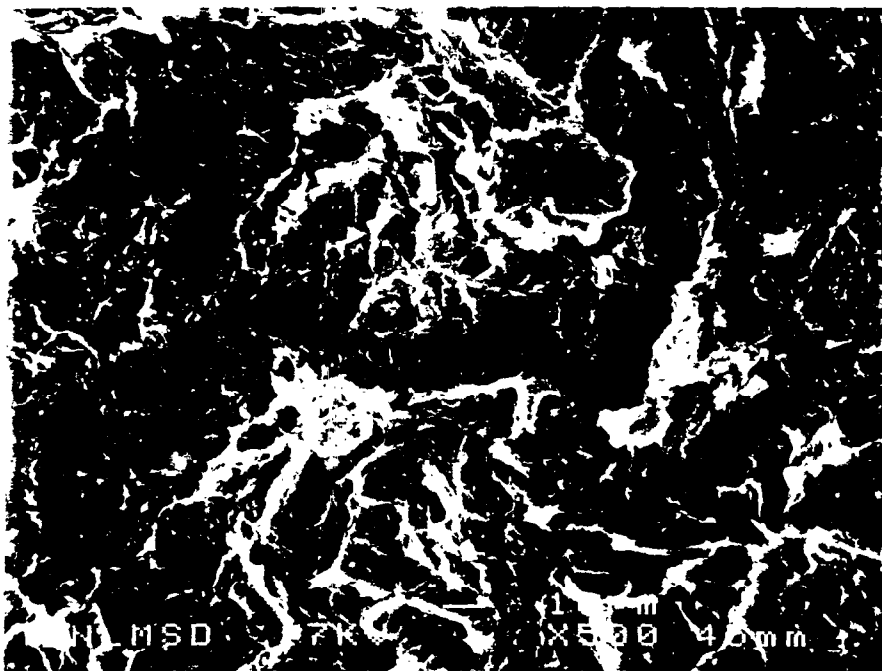
Figure 21. Polymer fracture surface showing tearing and coalescence of voids.

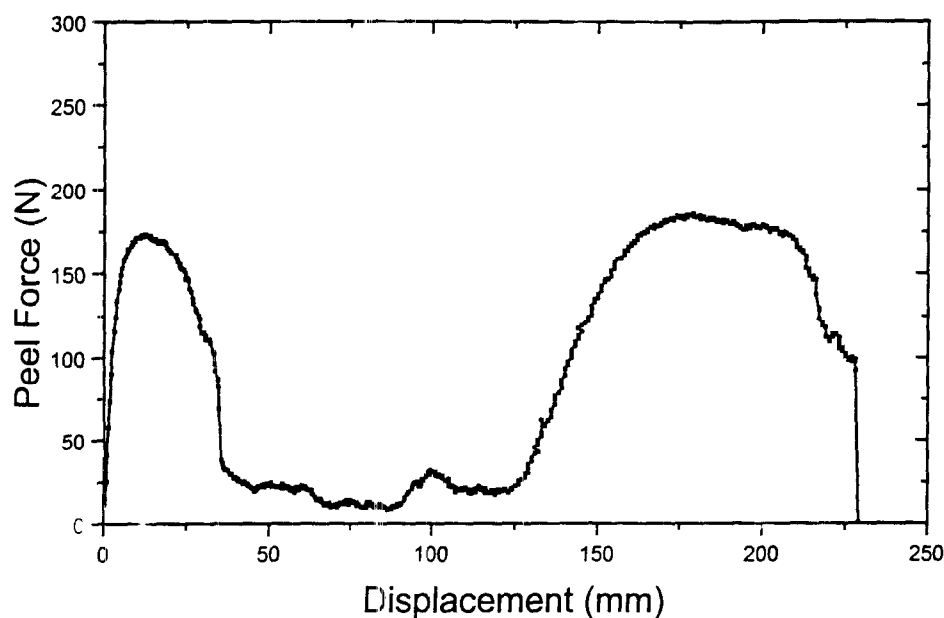
Figure 22. Peel force-displacement curve for EMAA exposed to *T. ferrooxidans*.

Failure in these panels was totally adhesive. The peel load versus displacement curves showed similar form to those obtained from the panels exposed to brine. The strips cut from outside the test cell had relatively a constant load required to peel the coating. The average peel strength was 6.64 N/mm. Load versus displacement curves obtained from area of exposed coating had a bathtub shape with higher loads being measured outside the test cell. Plastic deformation of the EMAA also occurred in the latter areas. The extent of plastic yielding was greater than for the thicker coatings used in the brine tests due to higher bending

stresses. The peel strengths in the corroded areas were as low as 0.46 N/mm. Peel forces were less variable where corrosion occurred than for the specimens tested in brine and this is attributed to the absence of cohesive failure which is associated with higher loads and more extensive corrosion. Figure 22 is an example of peel test results in the exposed area. The spike in the flat section of the curve correlated with the uncorroded area directly above the liquid level.
